Failure analysis of surface-micromachined microengines

Kenneth A. Peterson, Paiboon Tangyunyong, and Alejandro A. Pimentel

Electronic Quality/Reliability Center, Sandia National Laboratories, M/S 1081

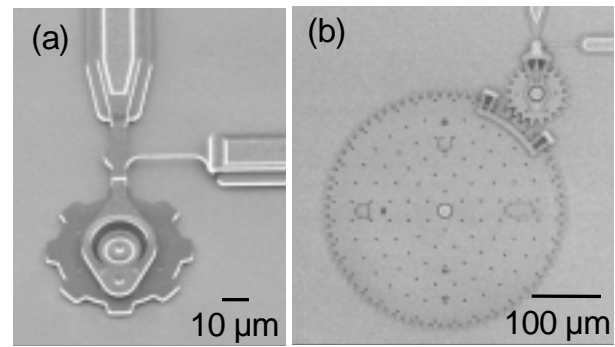
Figure 1. (a) An early design of microengine. (b) A binary counter, incorporating a new version of microengine that includes several modifications in both design and processing.

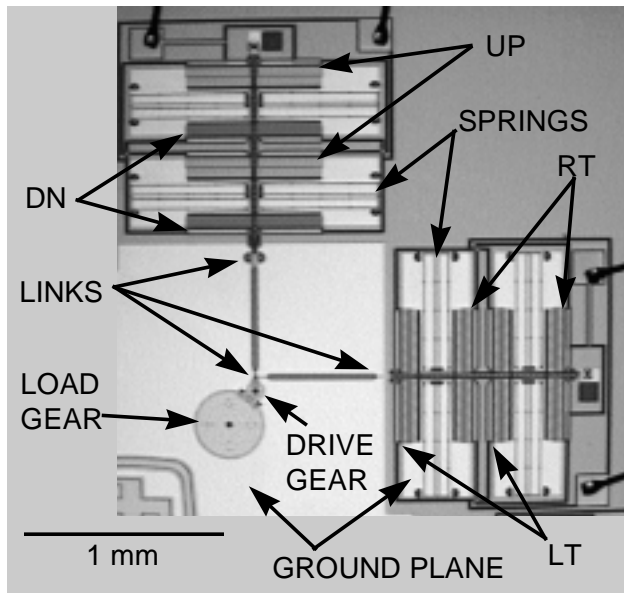
Figure 2. A low-magnification optical image of a binary counter (See arrows for various components including sets of combs to pull the shuttle to the right (RT), left (LT), up (UP), and down (DN) through link arms (links).

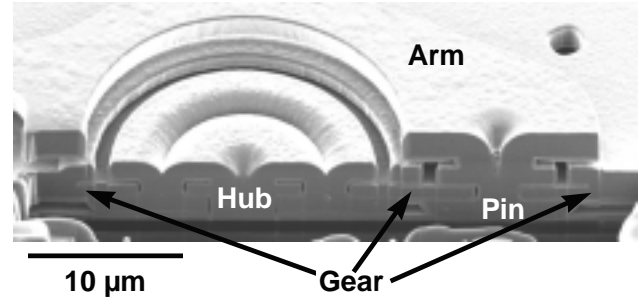
Figure 3. Focused ion beam (FIB) cross section of the drive gear and pin joint in a binary counter.

One complication from using the FIB has been observed. Sputtered material can redeposit from the area being milled in a line of sight fashion on the undersides of suspended members. This can create the appearance of a separate layer, such as the light contrast layer visible in the FIB section of Figure 3. This material is thickest at

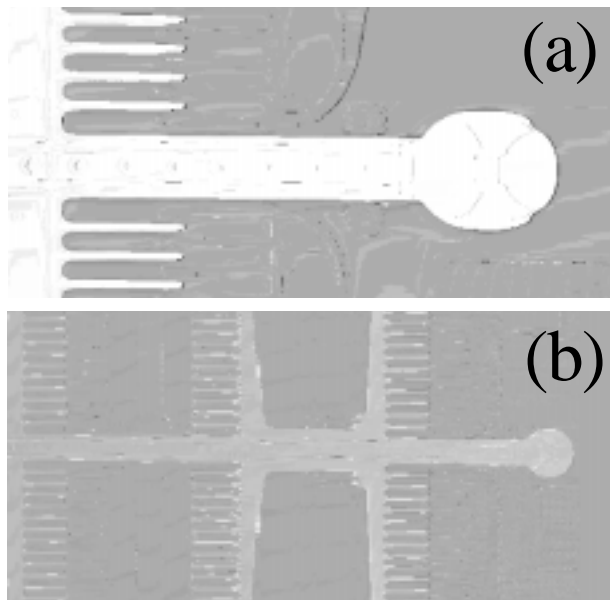
Figure 5. (a) A high-magnification and (b) a low-magnification extended depth-of-focus images of movable comb and shuttle in a binary counter showing levitation of both components under power.

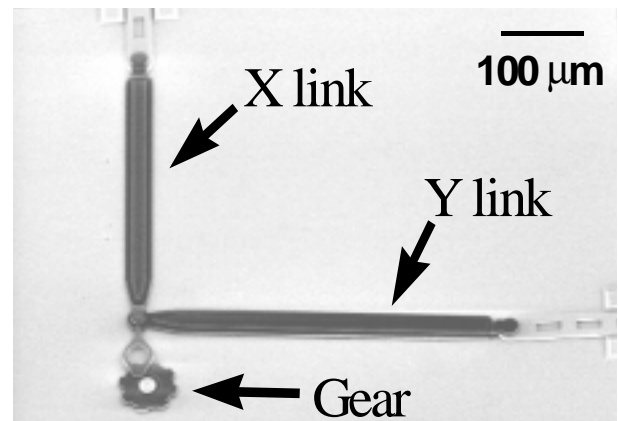
contrast image of a gear and link arms with pin joints. The passive voltage contrast shows that the electrically floating arms and gear are charged positively (dark) with respect to the gear hub and shuttle, which have direct contact to ground. The passive voltage contrast image of Figure 11 shows a microengine with flexible links which provide a direct connection to ground through the shuttle and springs. In this case, the indirect contact is between the gear and link at a pin joint and between the gear and its hub. In the flexible link case, only the gear is charged positively with respect to the grounded elements.

Figure 10. Passive voltage contrast showing charging of link arms and gear at 1 keV in the SEM.

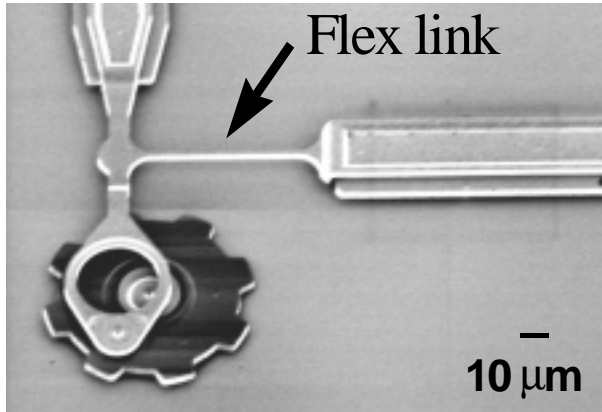
Figure 11. Passive voltage contrast showing charging of the gear only with respect to ground plane, hub, and link arms at 1 keV in the SEM. Arrow indicates flexible link.

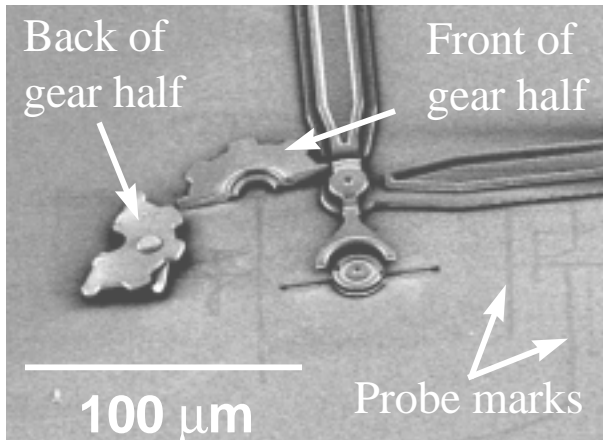
Figure 14. Microengine gear which has been micro-sectioned in the FIB and separated for SEM examination of bearing surfaces.

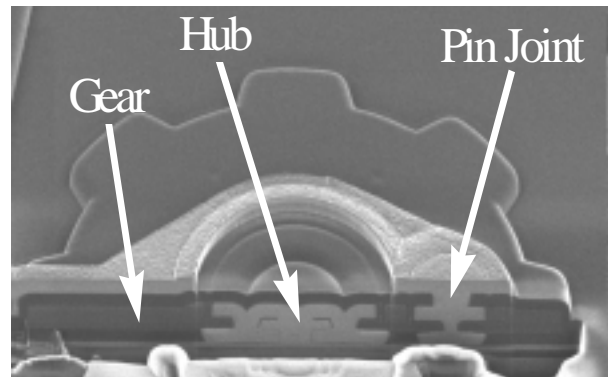
Passive and active voltage contrast imaging using FIB without charge neutralization⁶ has also been useful on MEMS. For example, passive voltage contrast accounts for the dark appearance of the gear in the cross section of Figure 17, as it is electrically isolated in encapsulating glass and thus acquires a positive charge

Figure 17. FIB section of unreleased gear showing different voltage contrasts between hub/pin joint and gear.

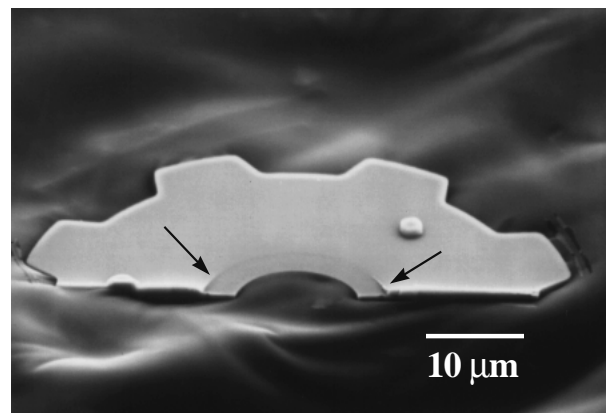
the milled edge, tapering back into the sample. Because this redeposited material is masked from the bearing surface by the flange of the hub, it might be confused with a wear track on the gear. An example of this is shown in Figure 18.

Figure 18. Micro-sectioned gear bottom surface showing FIB re-deposited material (arrows).

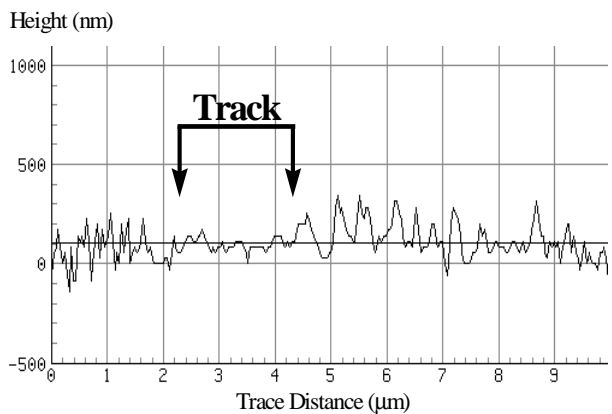
The atomic force microscope (AFM) provides very detailed topographic images and surface traces. Figure 19 shows the wear debris on the drive gear of a failed binary counter similar to those shown Figures 8 and 9. AFM was also used to measure the surface roughness of the wear track shown in Figure 7. Figure 20 shows a topology image of an area which includes the wear track. Smoothing was observed in the track, compared to the region outside the track. A line scan across the track is shown in Figure 21.

Figure 21. Topology line scan across wear track in Figure 20.

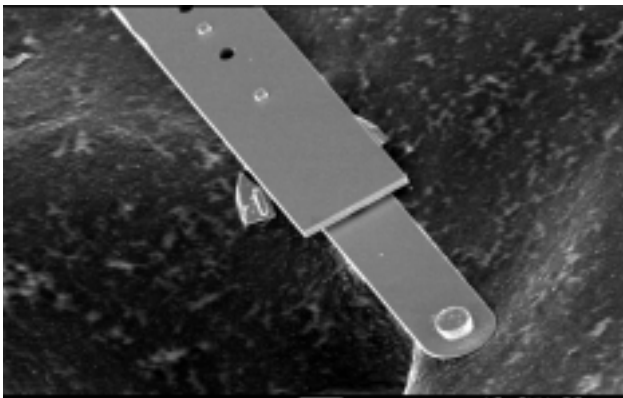
Careful removing elements of a microengine with a conductive laboratory adhesive tape used for SEM mounting has added another dimension to the analysis of microengines. The lift-off technique allows examination of the bottom surfaces of engines (Fig. 23) that provide additional information (such as the accumulation of wear debris or evidence of damage to pin receiver holes) for determining failure modes of the defective and failed microengines.

Figure 23. SEM image of a pin-joint shuttle which was lifted off using conductive adhesive tape.
